# **INDOOR AIR QUALITY ASSESSMENT**

**Riverbend Elementary School  
Athol-Royalston Regional School District  
174 Riverbend Street  
Athol, Massachusetts**

Prepared by:  
Massachusetts Department of Public Health  
Bureau of Environmental Health Assessment  
Emergency Response/Indoor Air Quality Program  
August 2003

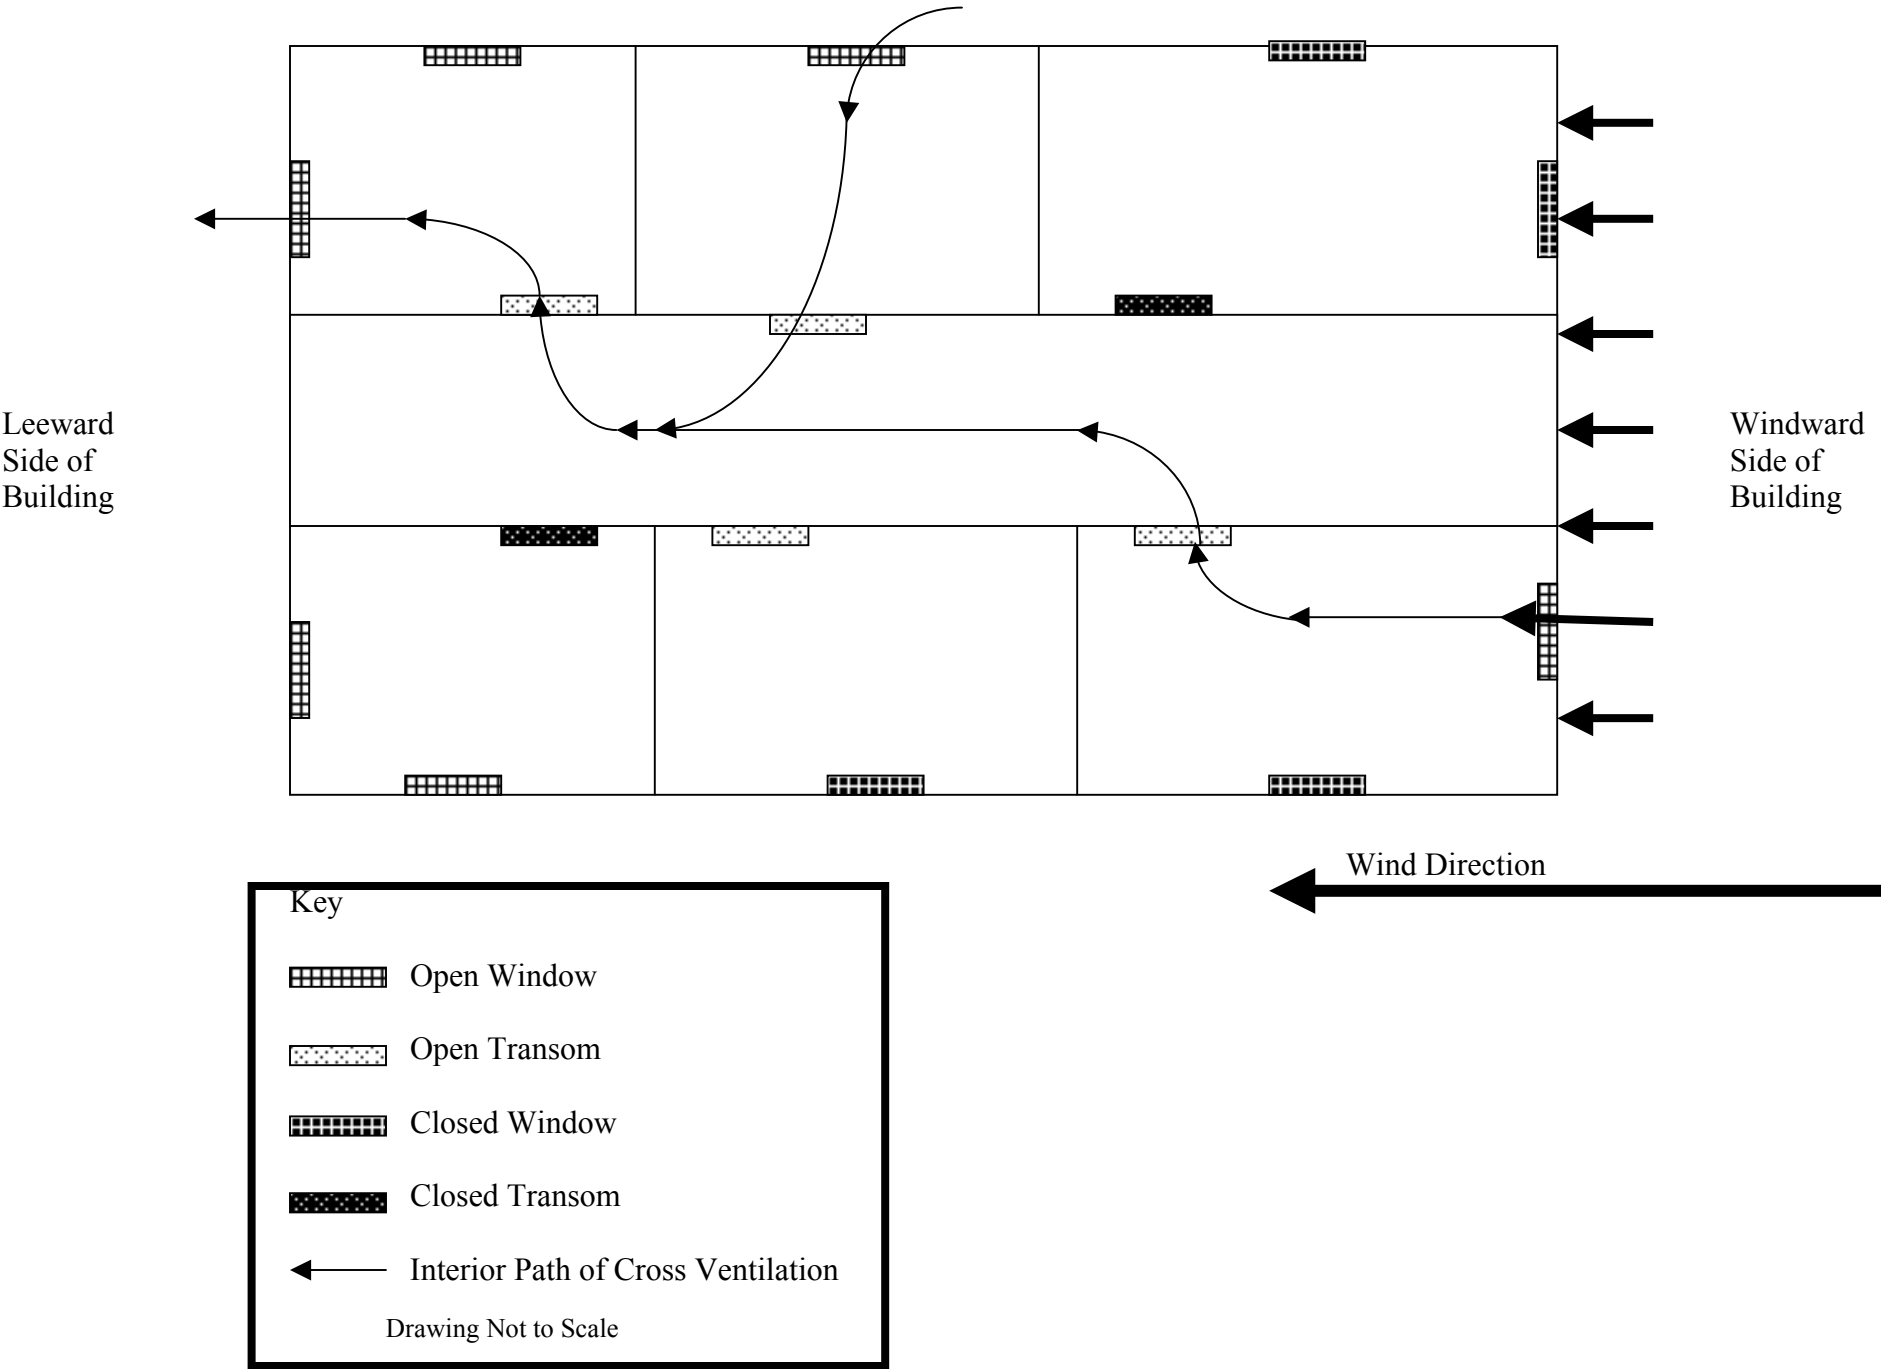
Figure 2

During summer months, ventilation within the 1906 section is controlled by the use of openable windows in classrooms. This section was originally configured in a manner to use cross-ventilation to provide comfort for building occupants. The building is equipped with windows on opposing exterior walls. In addition, the building has hinged windows located above the hallway doors. This hinged window (called a transom)(see Picture 4) enables occupants to close the hallway door while maintaining a pathway for airflow. This design allows for airflow to enter an open window, pass through a classroom, through the open transom, enter the hallway, pass through the opposing open classroom transom, into the opposing classroom and exit the building on the leeward side (opposite the windward side) (see Figure 1). With all windows and transoms open, airflow can be maintained in a building regardless of the direction of the wind. This system fails if the windows or transoms are closed (see Figure 2). Each classroom would have a long pole with a hook that was used to open the hoop latch that locks the transom. All of the transoms in the 1906 building have been permanently sealed.

Inhibition of Cross Ventilation in a Building with Several Windows and Transoms Closed
